Pipeline and Hazardous Materials Safety Administration

Office of Pipeline Safety

Construction & Material Quality Issues

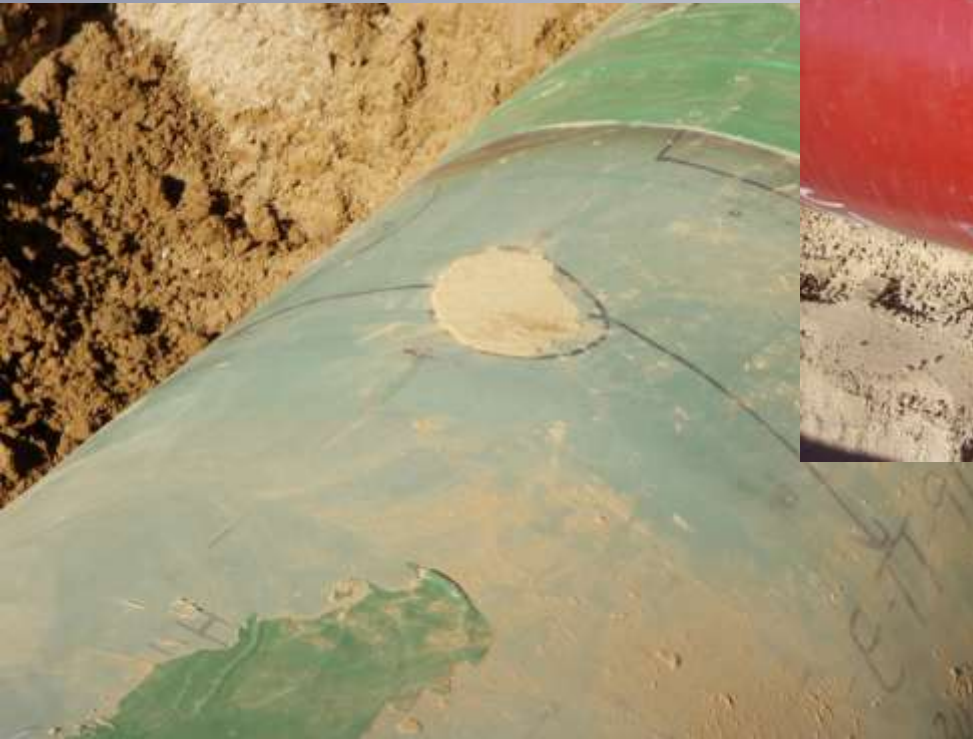
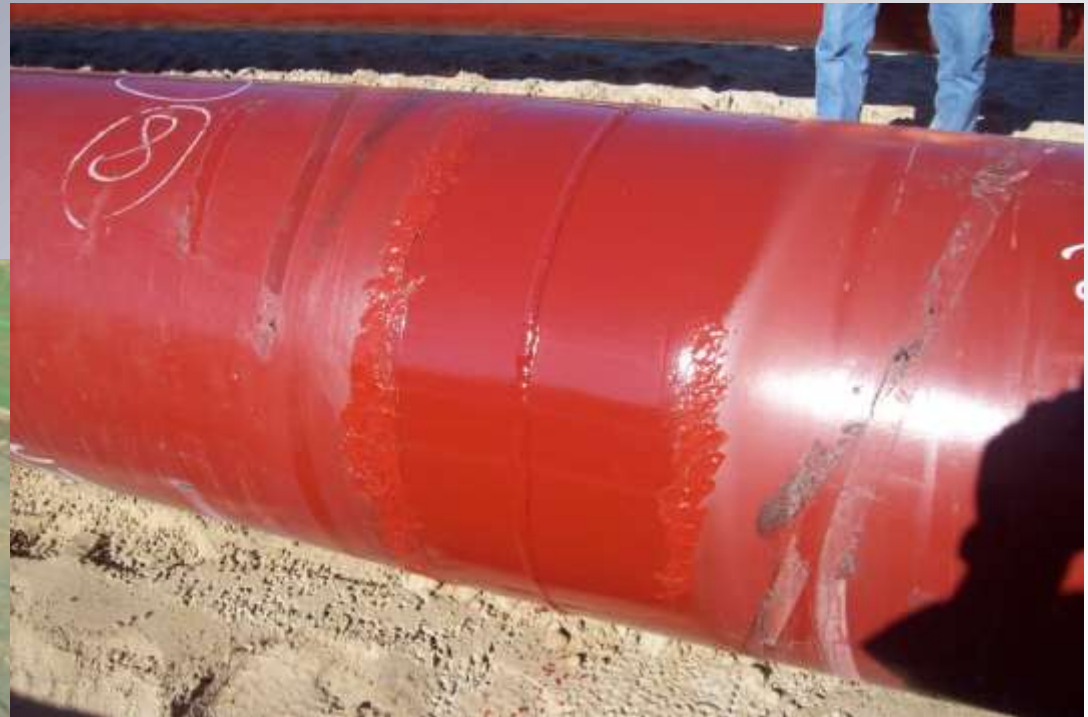
- **Coating Issues**

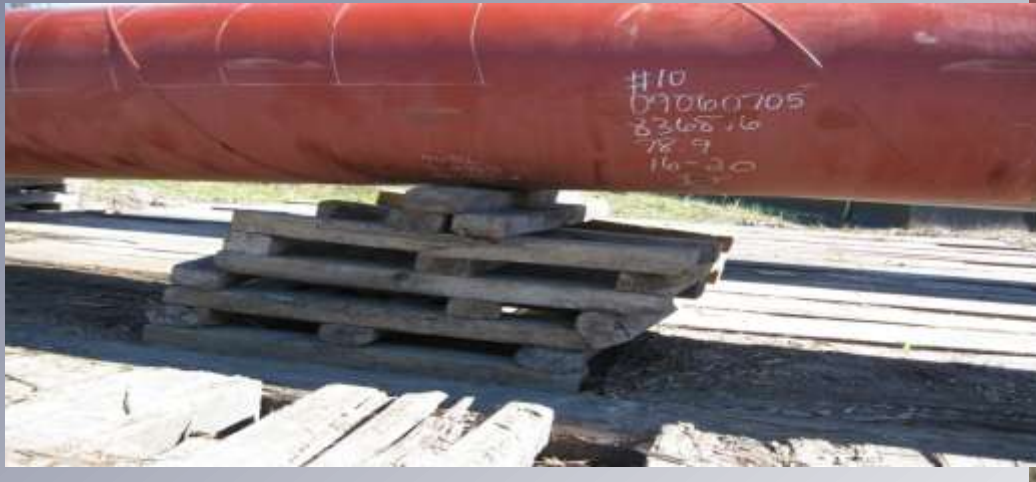
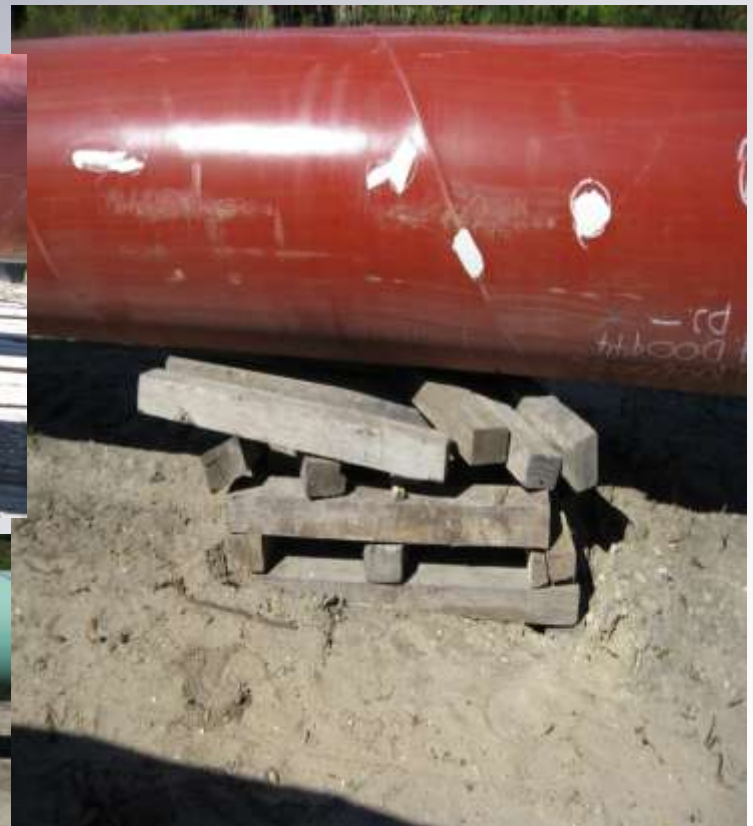
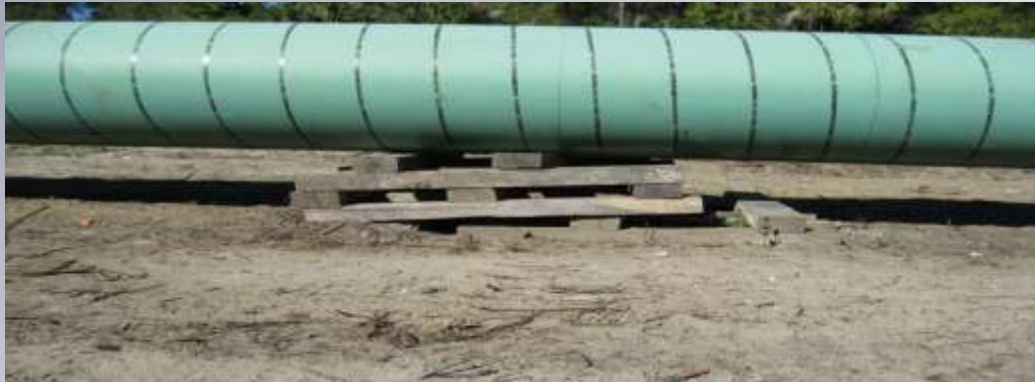
Coating – due to pipe support

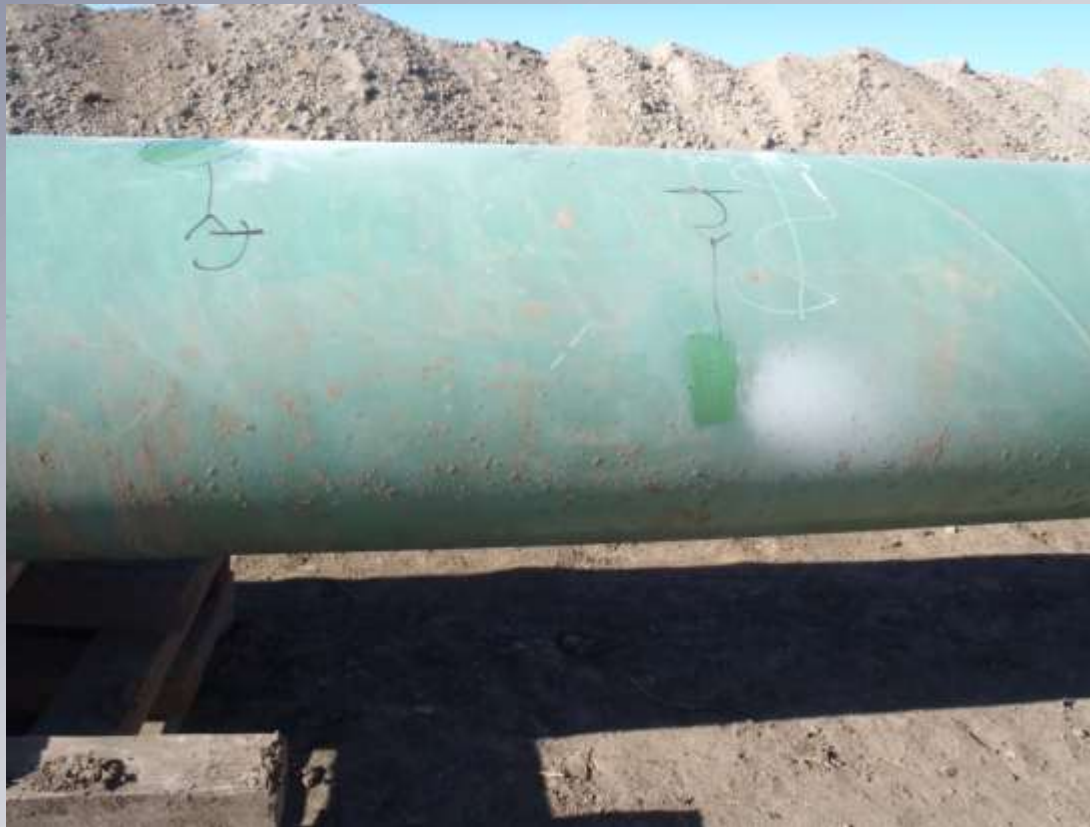
Construction Issues - Jeeping Over Soil

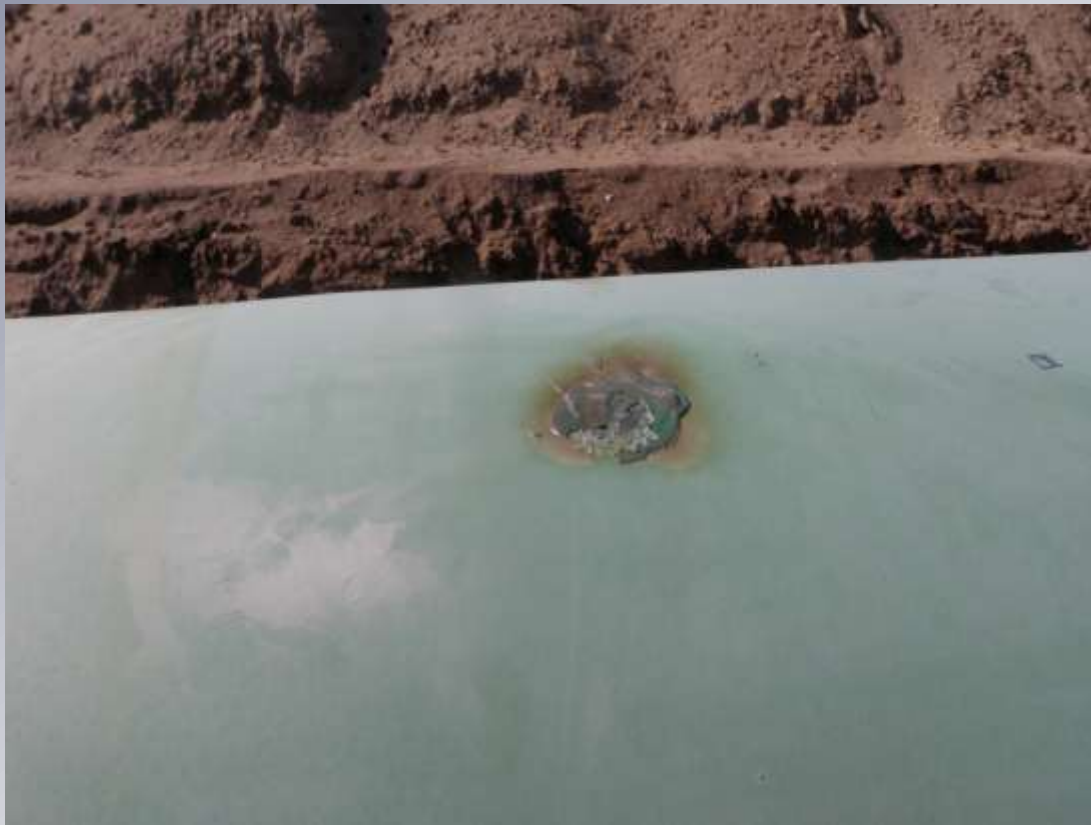
Coating - improper patch stick application

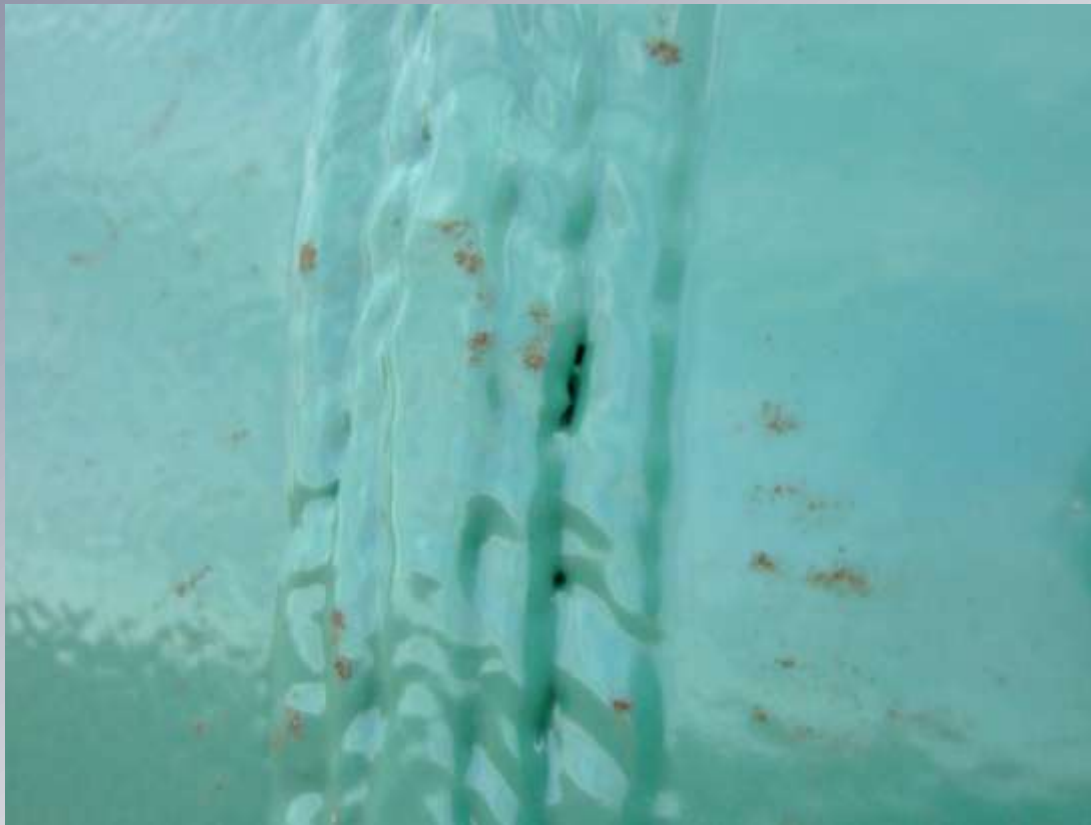
Coating – poor application of FBE

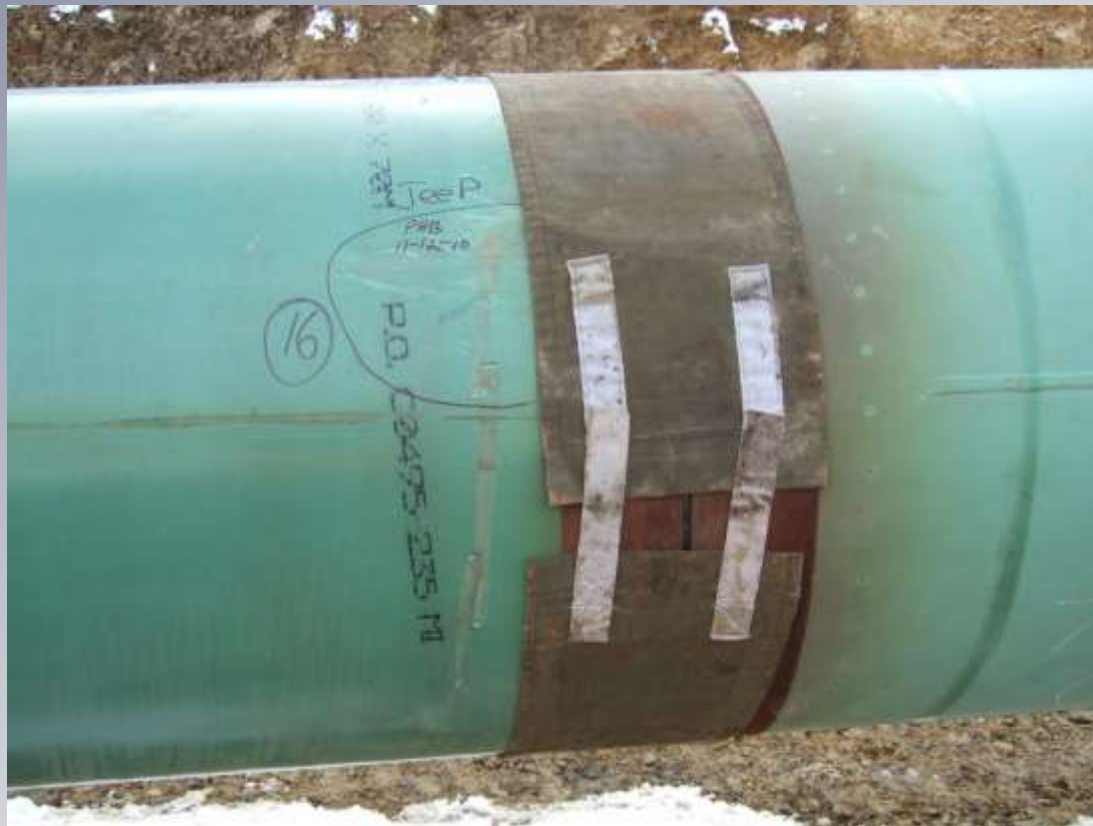
Coating – damaged by welding band

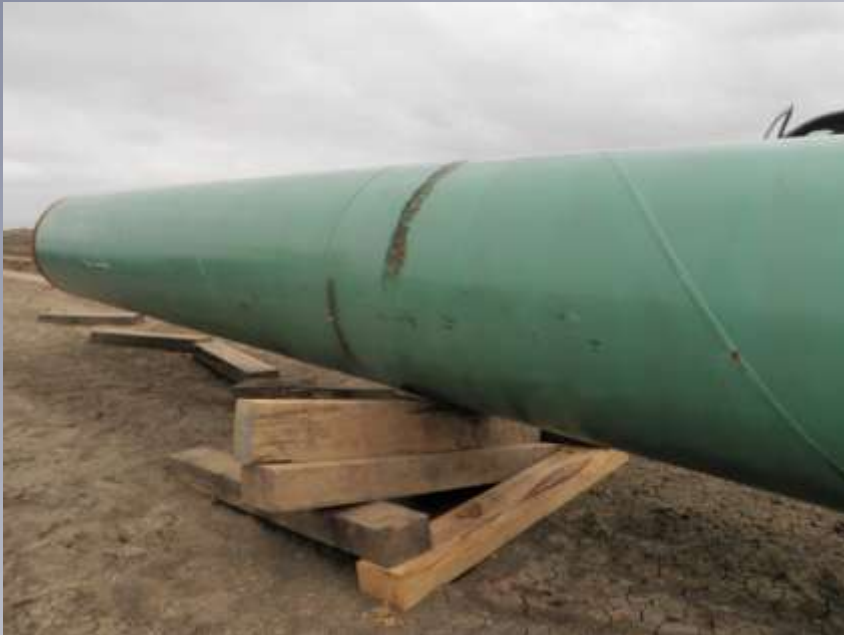
Coating – poor factory application

- **199 jeeps on section**

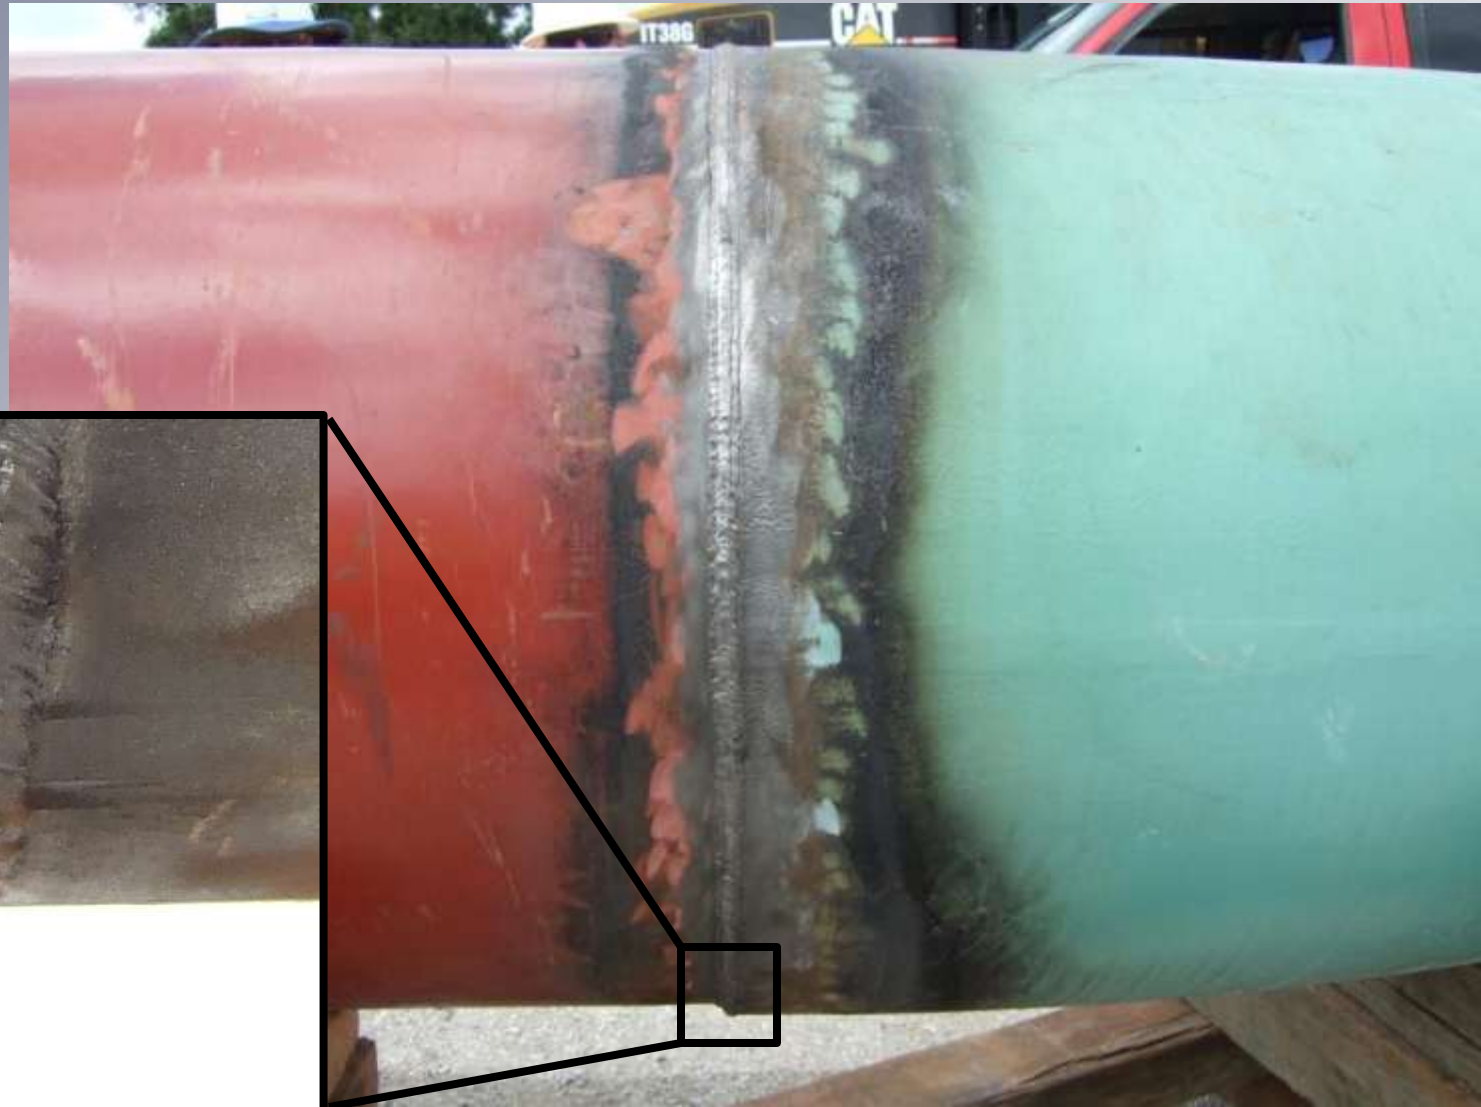
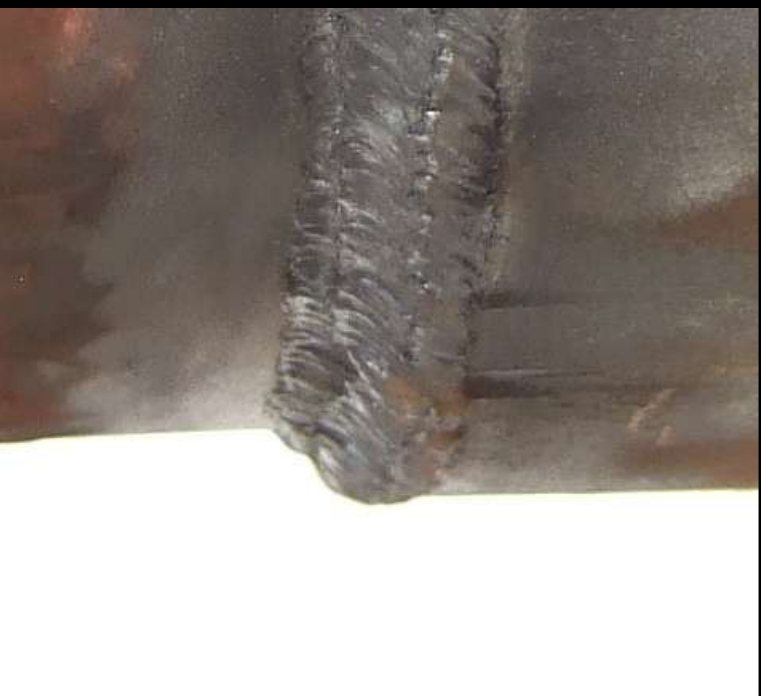
Misalignment at Segmented Bend

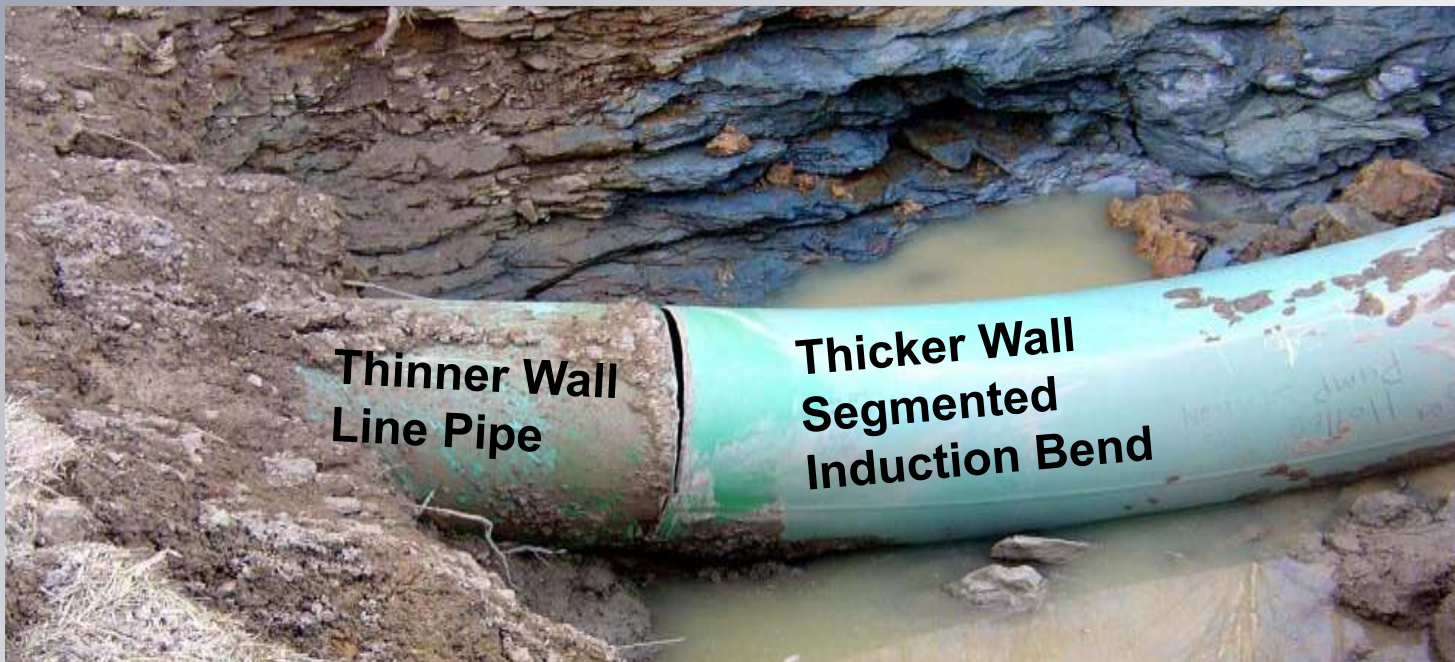
ADB-10-03 Girth Weld Quality Issues

- Misalignment, thickness transitions, and welding practices
- Below in-service failure occurred at 65% SMYS

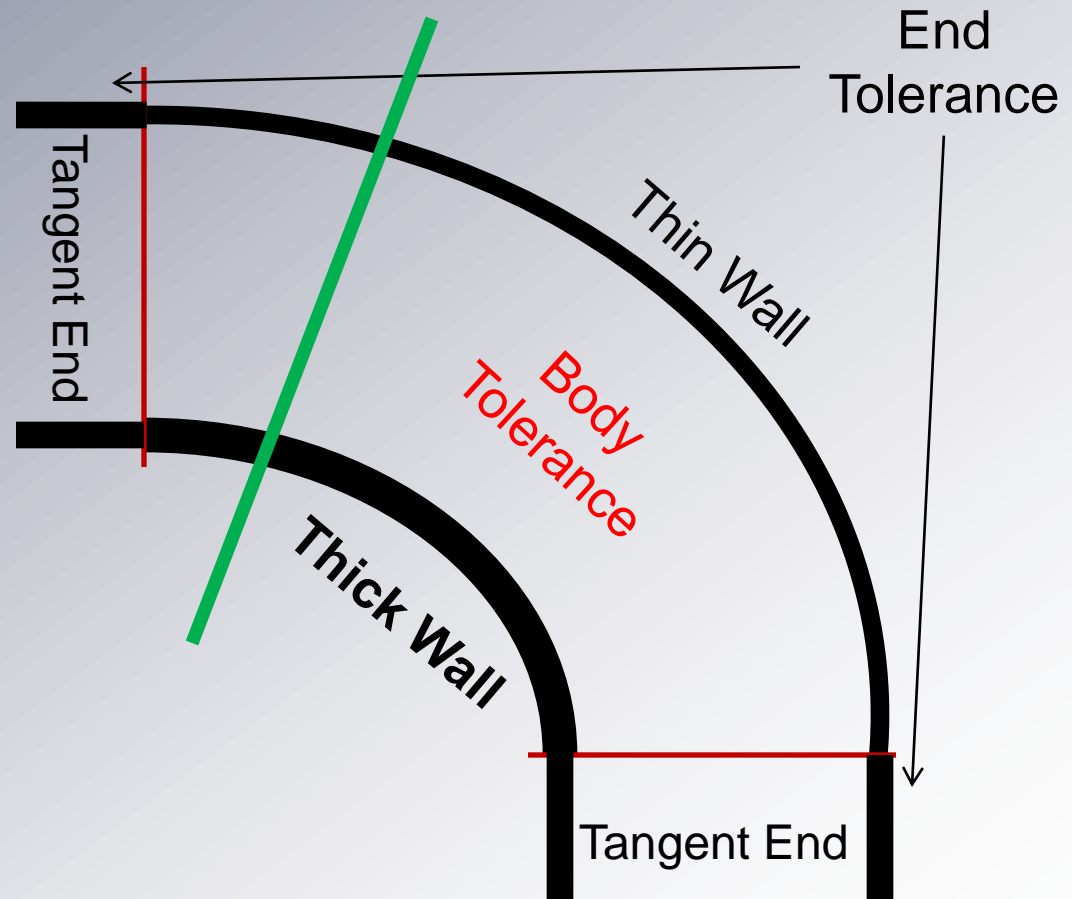
Hot induction bend cross-section

- If cutting bends, use **segmentable** bends with tighter body tolerance
- Ends should meet:
 - API 5L dimensional limits
 - API 1104 fit-up requirements

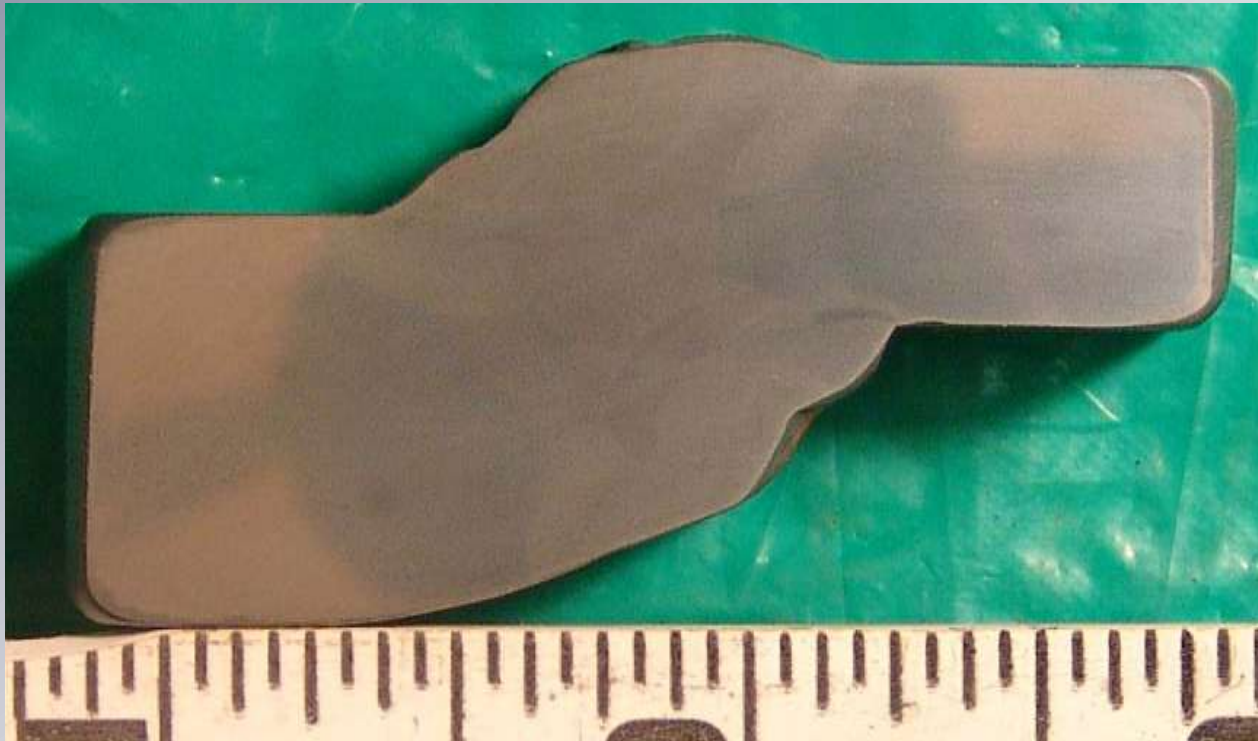
- Alignment – does it meet standards for API 1104

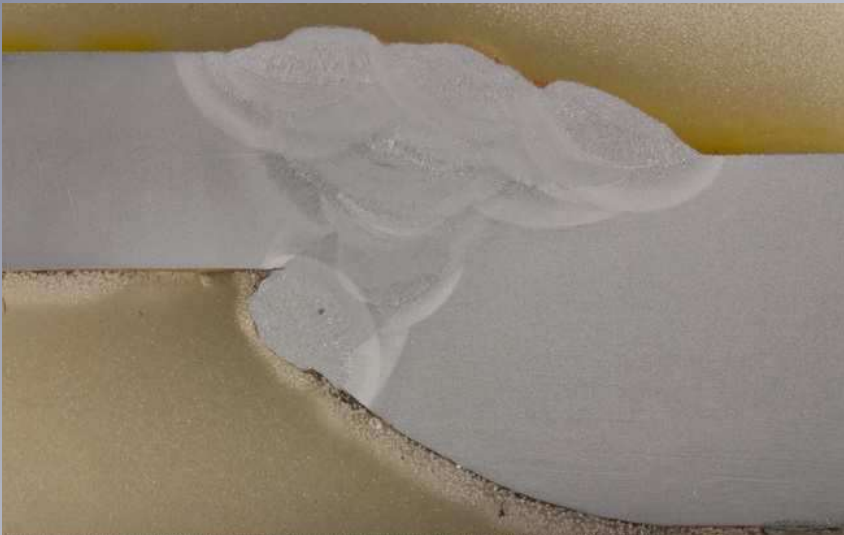
- **Poor back welding & misalignment**

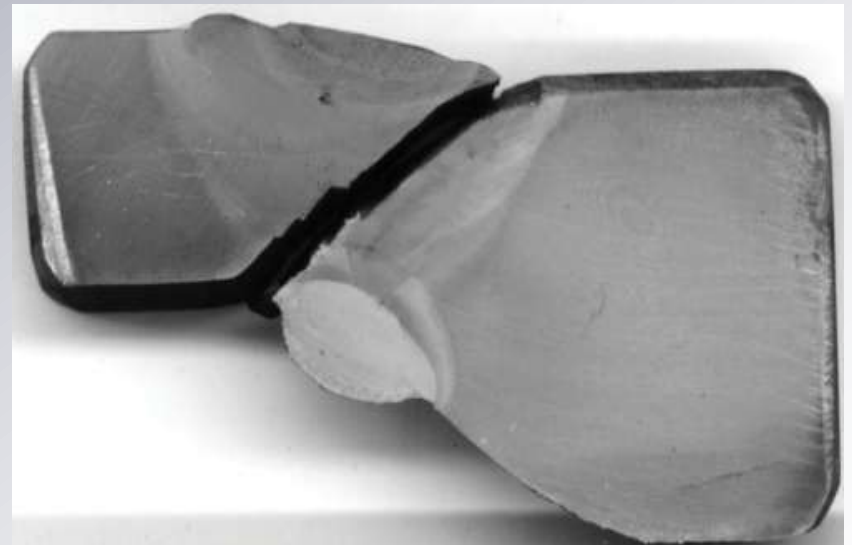
- **Improper ID back taper angle**

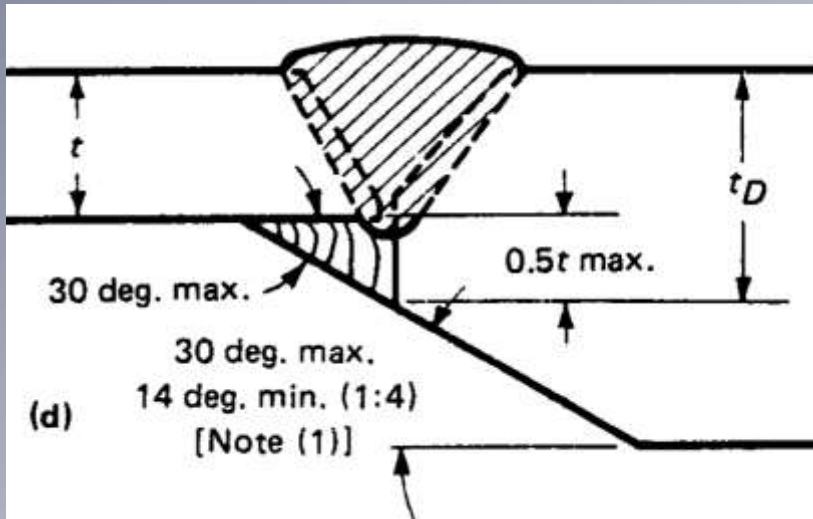
Improper Weld Transitions

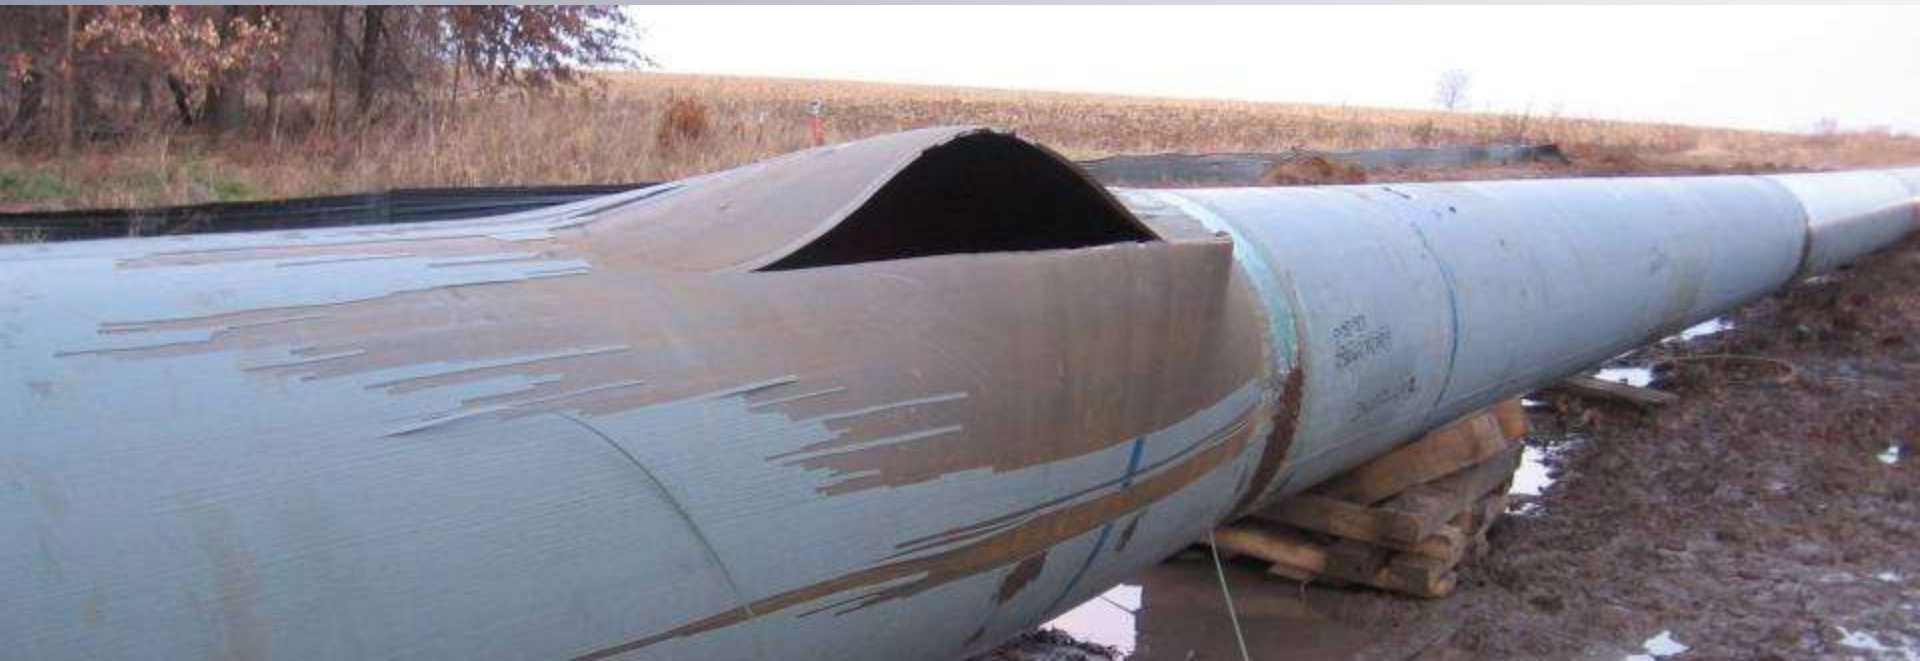
- Low strength X70 & X80
- Inconsistent chemical and mechanical properties
- Poor mill rolling practices
- Advisory Bulletin - ADB 09-01

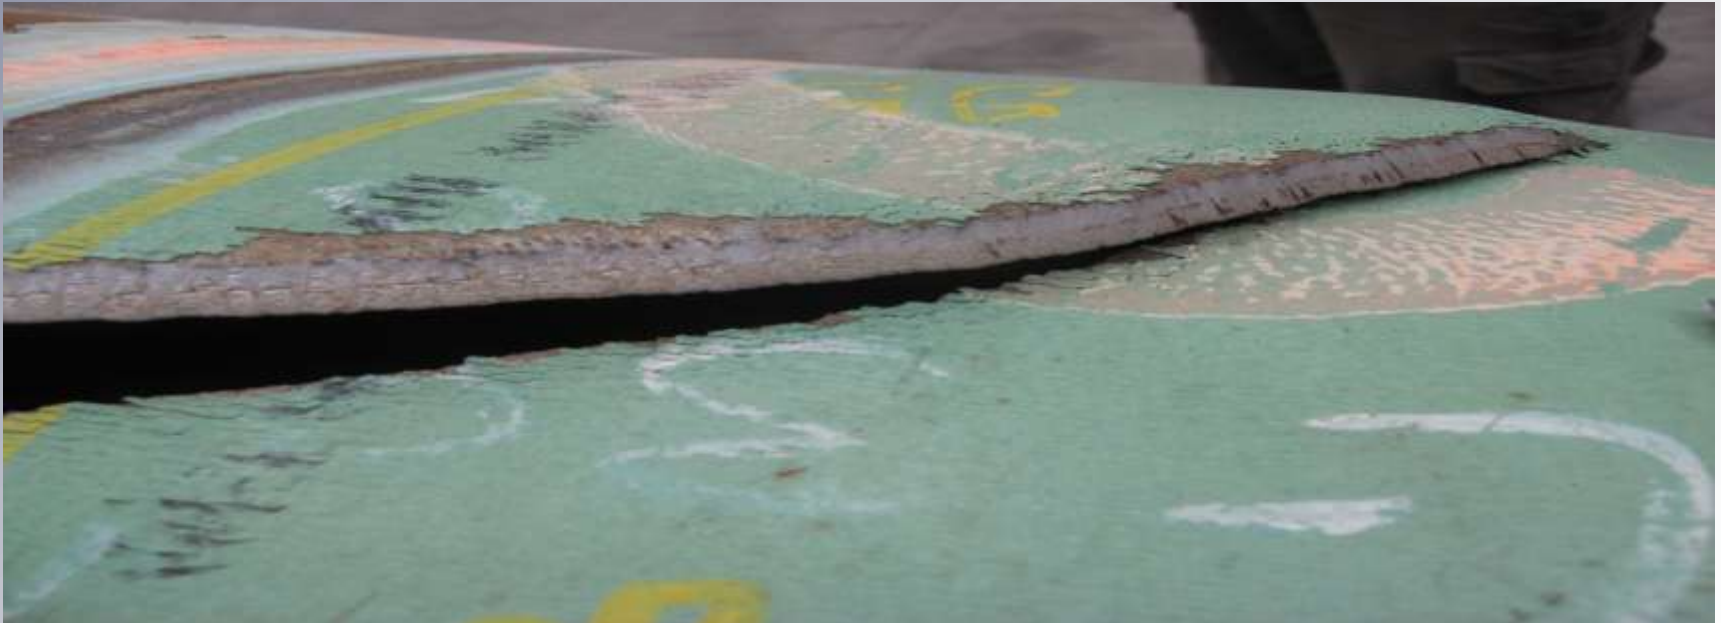
- **Low Strength Pipe**

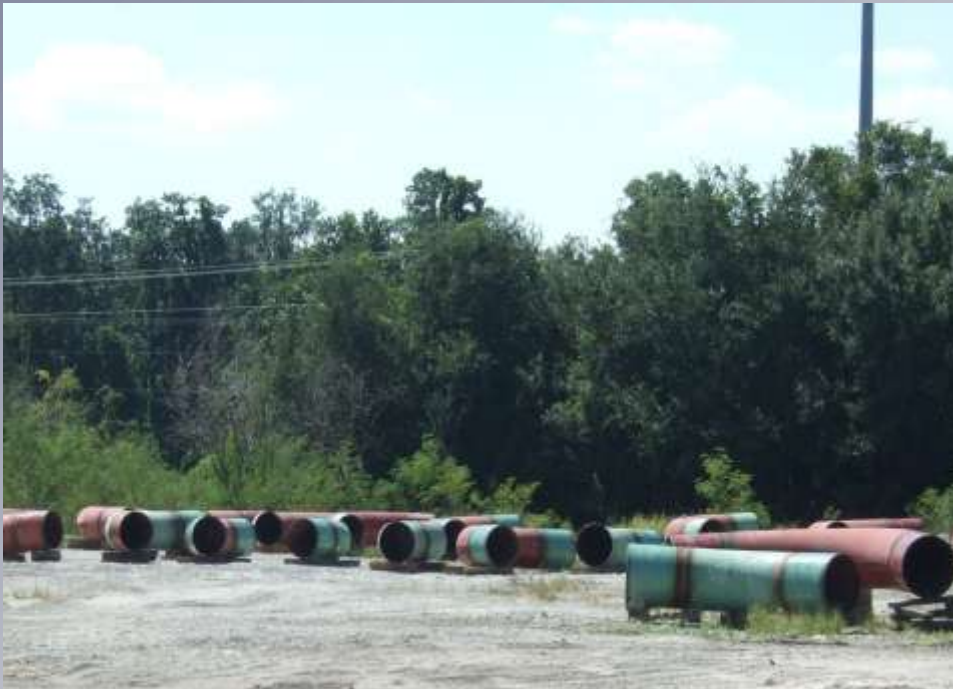
- **Several major projects have installed fittings of low strength material –**
 - **due to incorrect grade material and/or**
 - **post heat treatment**

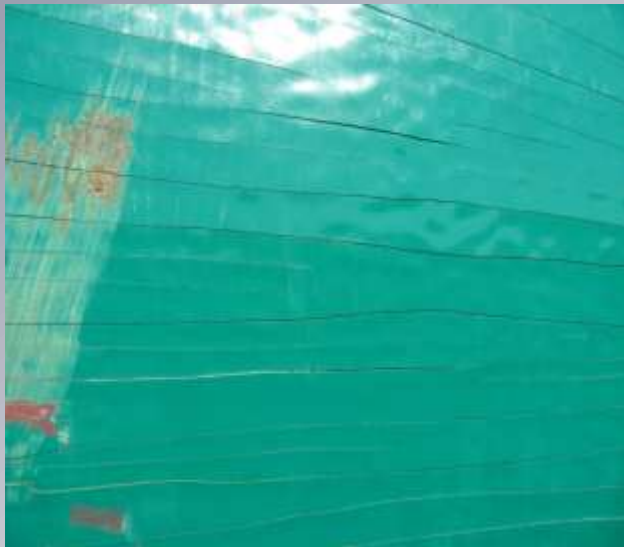
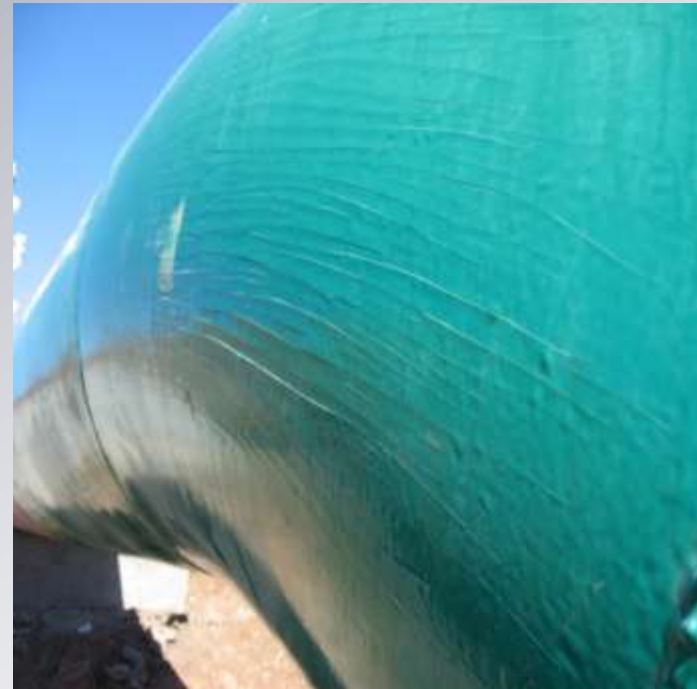
- **Coating is cracking due to expansion of fitting during testing**

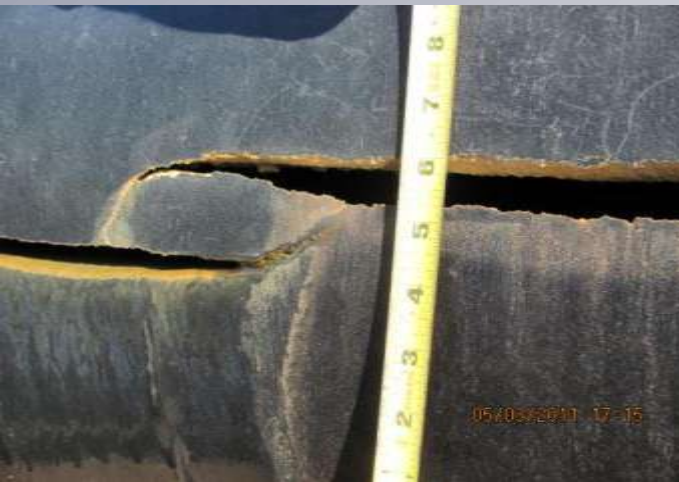
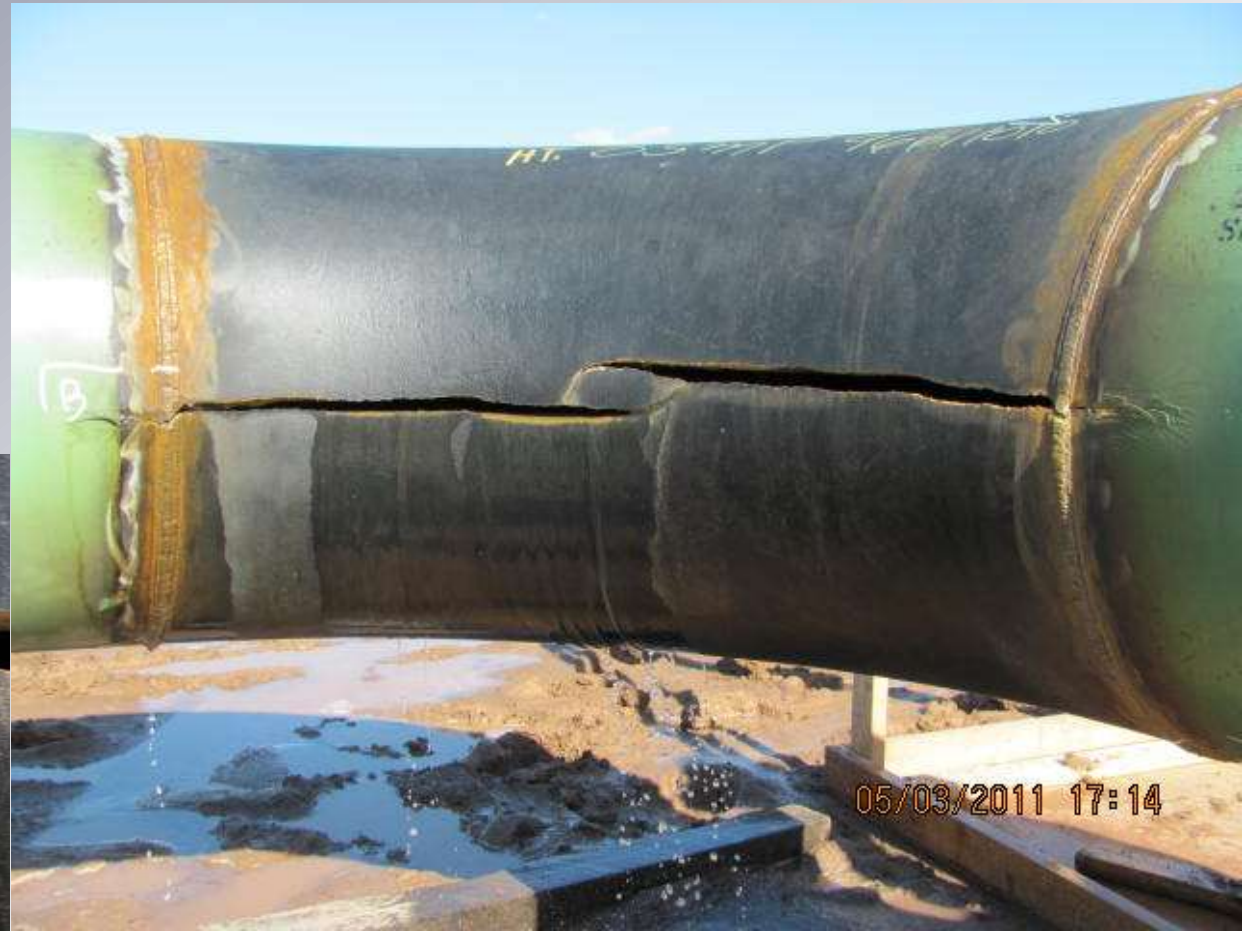
**Hydrotest failure
at 80% of test
pressure**

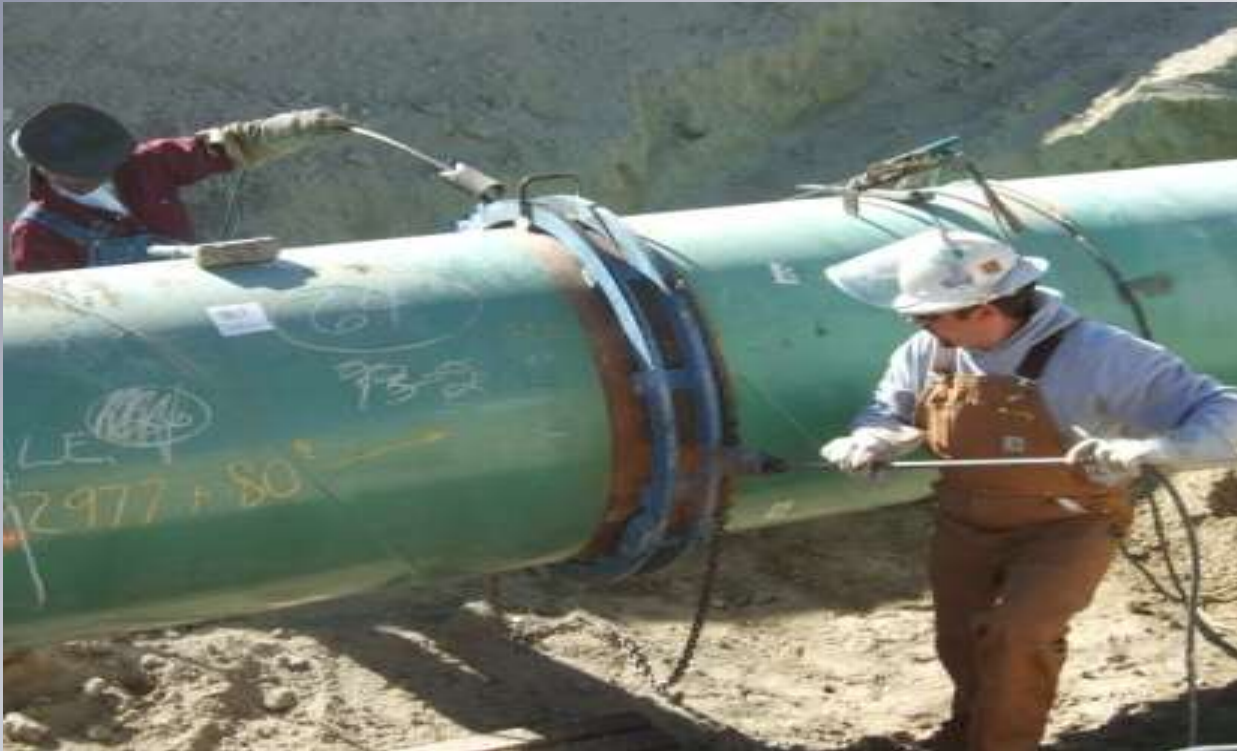
- Inadequate preheat temperature

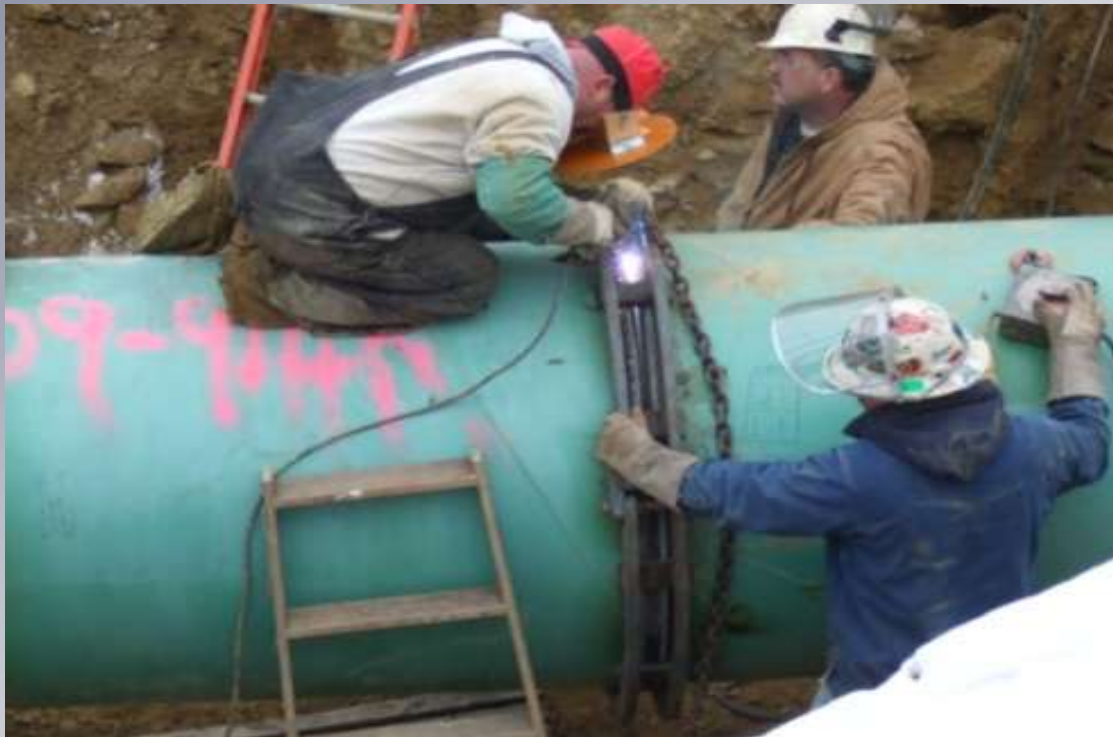
- **Releasing external clamp before 50% root pass is completed**

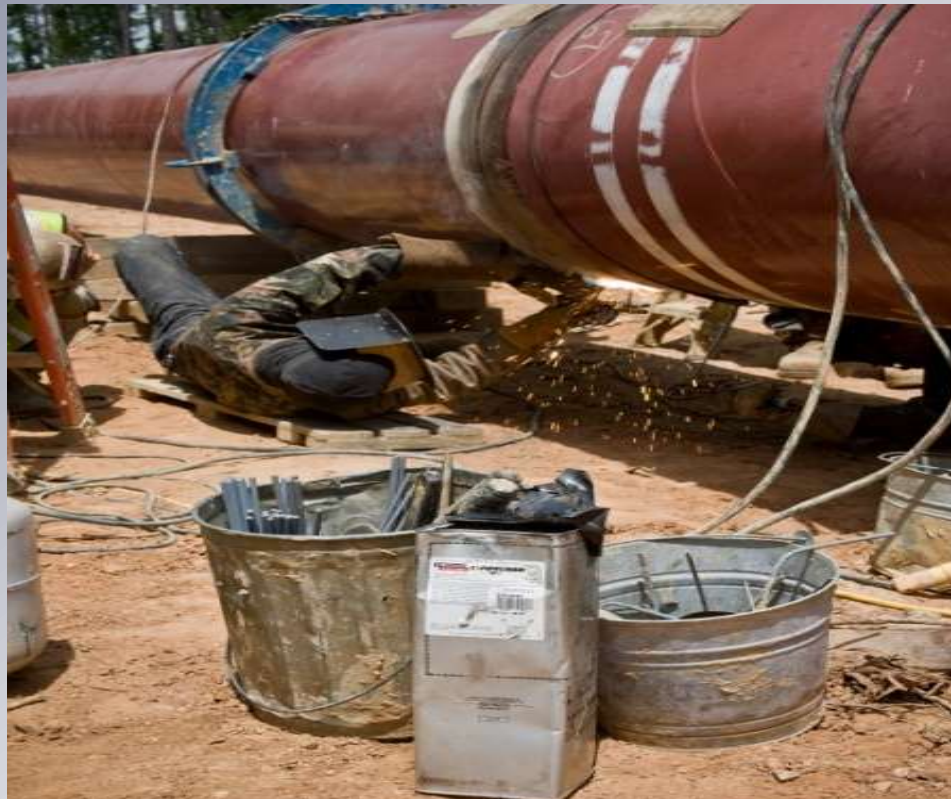
- **Improper low-hydrogen stick electrode storage**

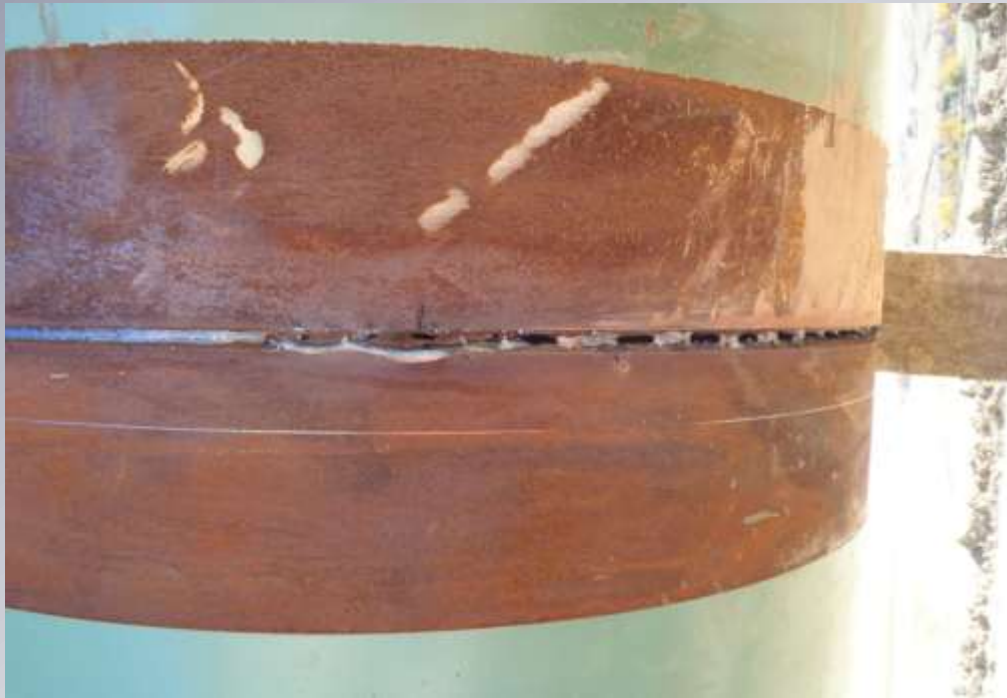
- **Improper Weld Gap**
